PROJECT: Preliminary Conservation Suitability Analysis for University of Colorado South Campus

COMPILED BY: City of Boulder, Planning, Housing and Sustainability

City of Boulder, Planning Housing & Sustainability
Preliminary Conservation Suitability Analysis
For University Of Colorado South Campus

November 2016

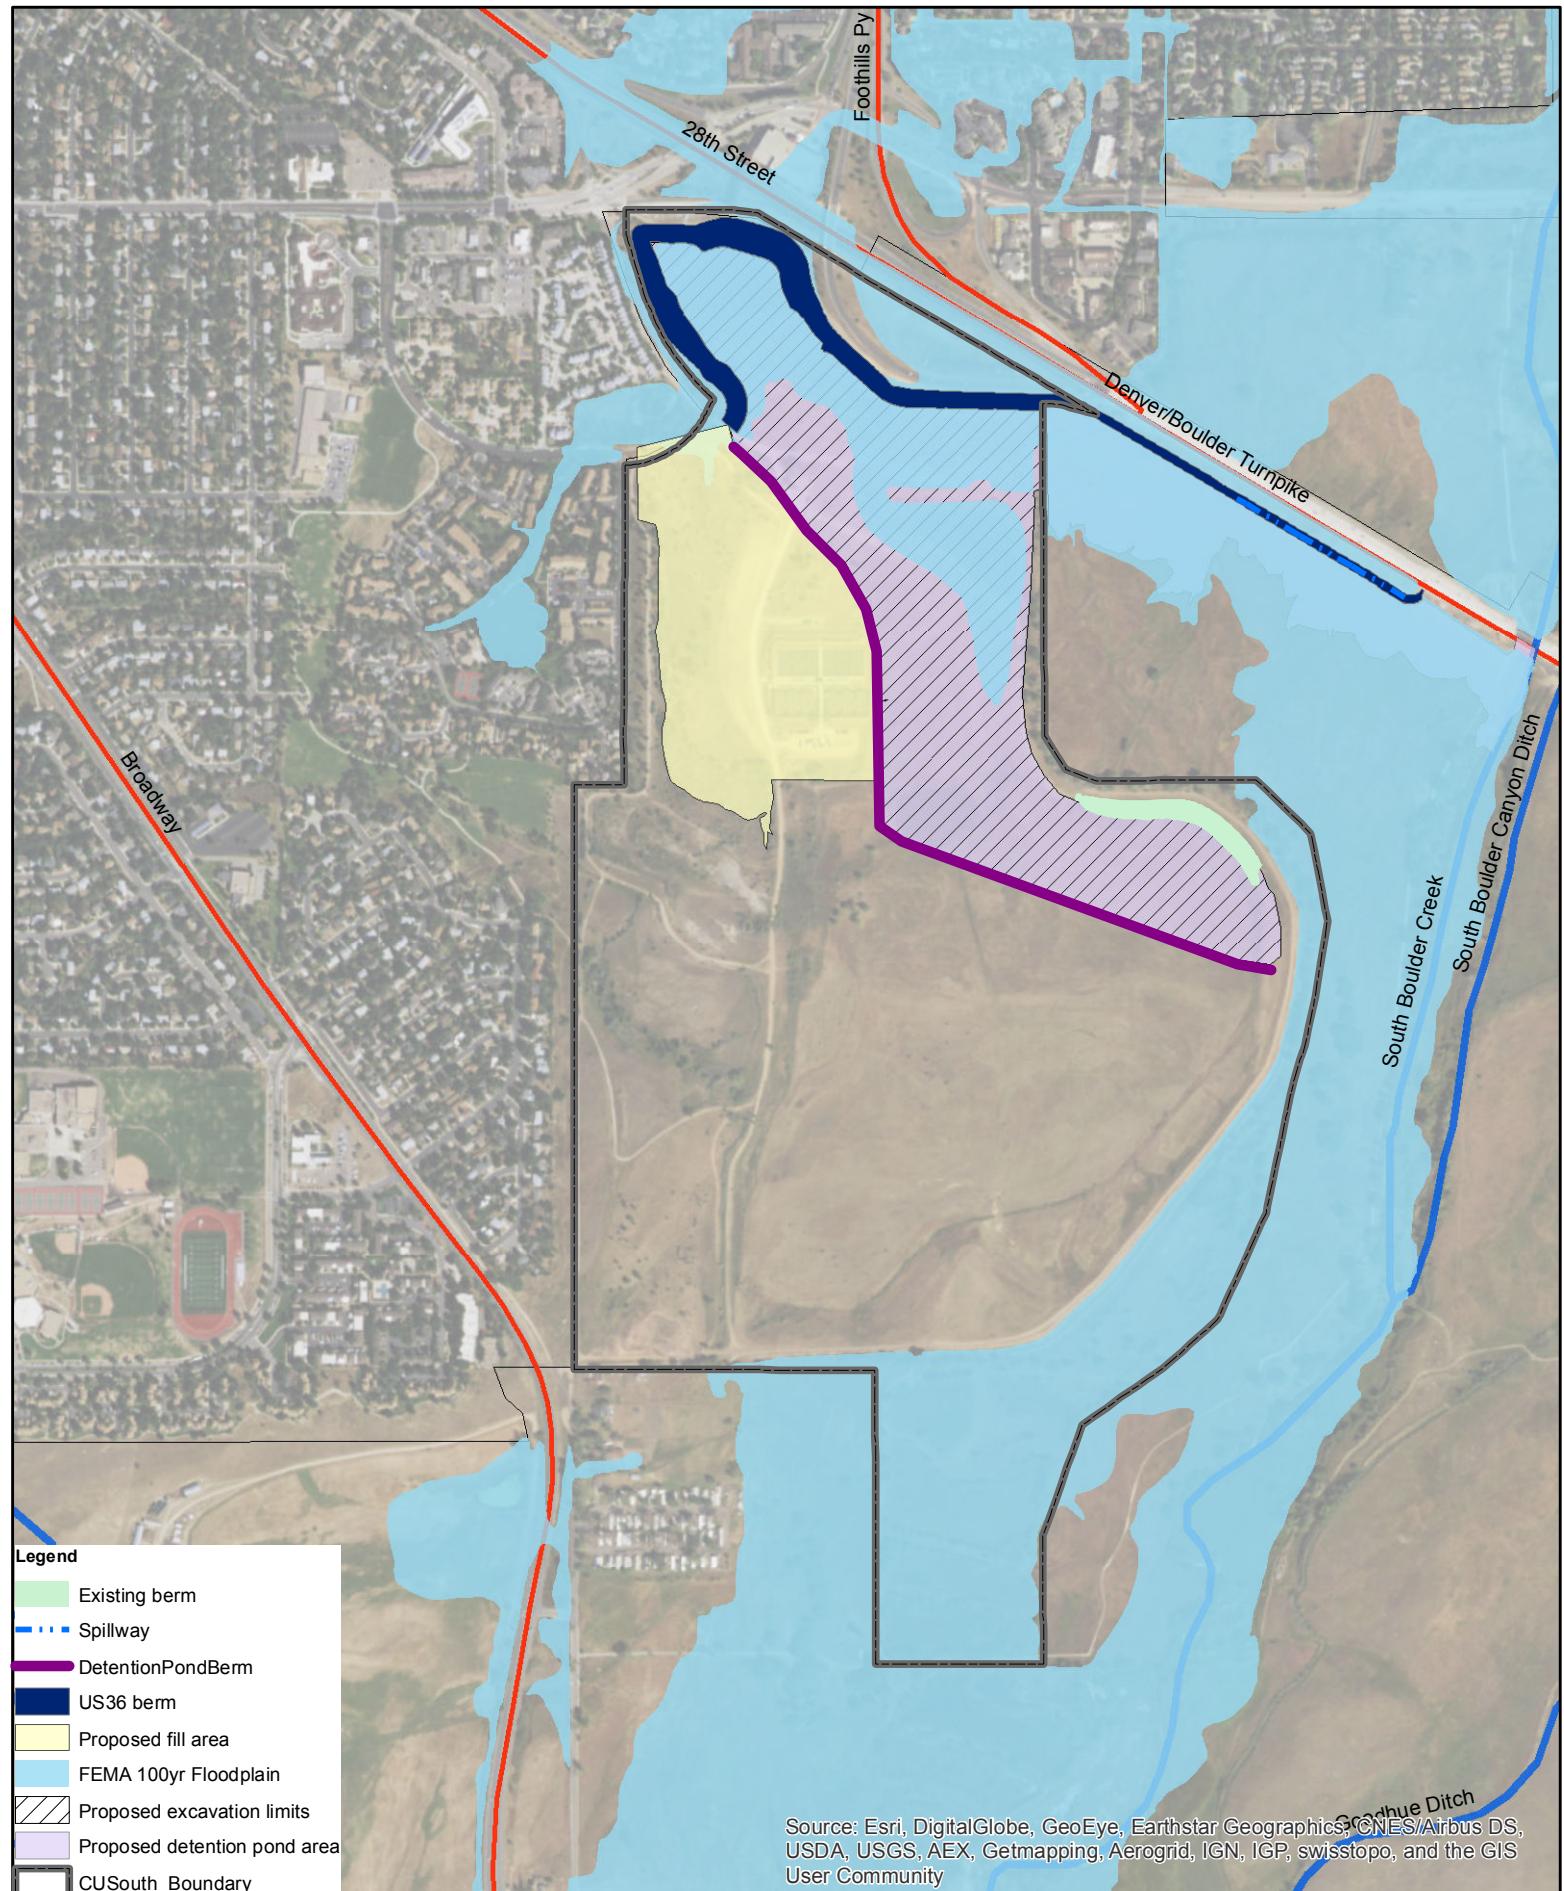
Figure 3
Flood Mitigation
Alternative D Features
CU South Campus

Major features of CU South include a flood control berm that parallels the eastern boundary and northern edge of the southern “panhandle” (refer to Figure 3). The western portion of the property is characterized by a steep topographic gradient that forms a terrace. The northern half of the property has 4 ponds interspersed with development, including tennis courts, maintenance buildings, parking lots, and roads. The interior of the property is could be characterized as a basin dominated by non-native grasslands.

Additionally, the 2015 South Boulder Creek Major Drainageway and Flood Mitigation Plan will be highly influential on future development scenarios of the property. The preferred Alternative D will entail construction of a berm along US 36, excavation of 81 acres in the northeast portion of the CU South property to create a detention pond, and fill of approximately 31 acres of the northwestern portion of the CU South property to 5370 feet a.s.l. (Figure 3). Of the seven alternatives considered, Alternative D minimized impacts to sensitive species from nearby OSMP properties and minimized impacts to sensitive environmental resources.

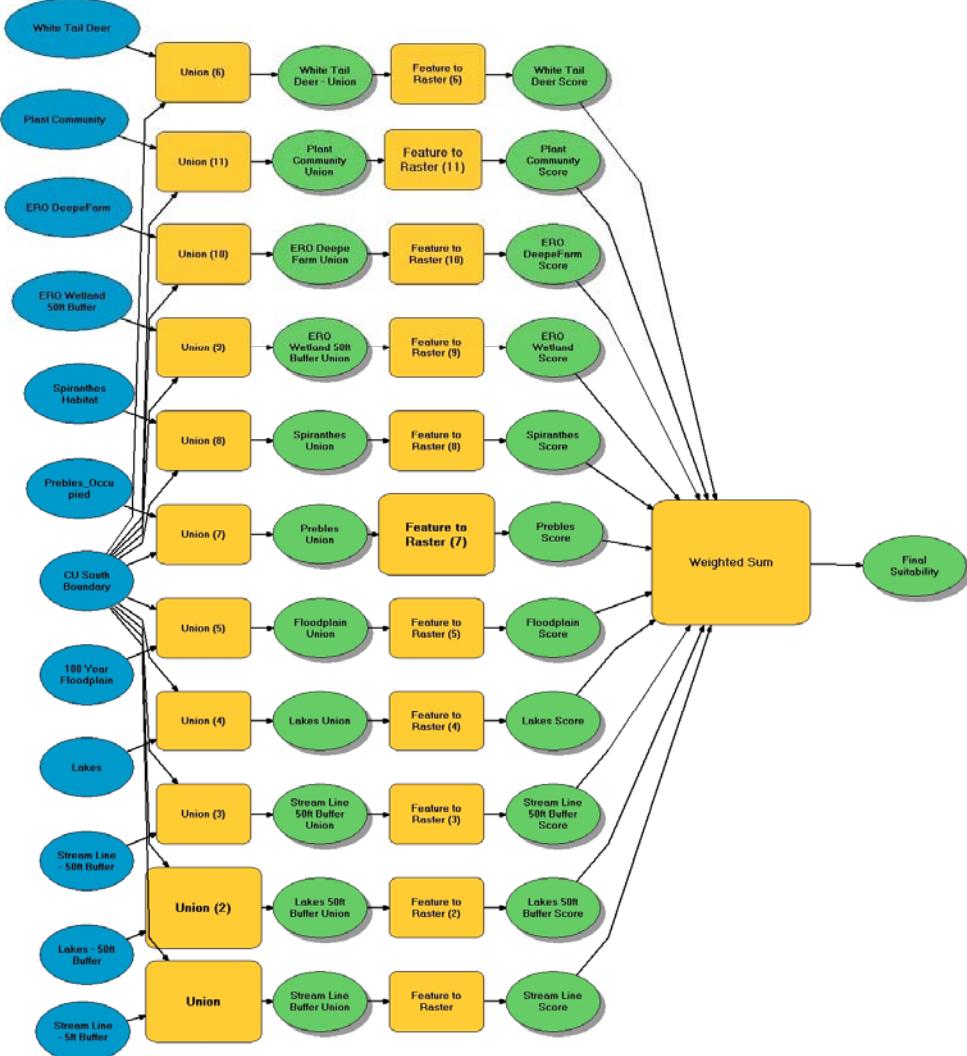
Figure 4 Model of GIS Analysis for CU South Property

To complete the GIS analysis, the layers of primary criteria (Table 1, Fig. 4) were compiled into a geodatabase and organized into feature datasets by analysis step. The first step of analysis required clipping data to the property extents to ensure each feature represented the same area of interest. All data were assigned the same projected coordinate system, NAD 1983 HARN State Plane Colorado North FIPS 0501, to ensure spatial accuracy and alignment.

The final step of the process was the execution of a weighted sum overlay using ArcGIS Spatial Analyst tools. This step combines all raster datasets that were created and scored previously by overlaying each feature and summing areas of overlap. The goal of the analysis is to highlight areas with the highest density of sensitive ecological features that will be less suitable for development (see Section 3, Summary of Findings).

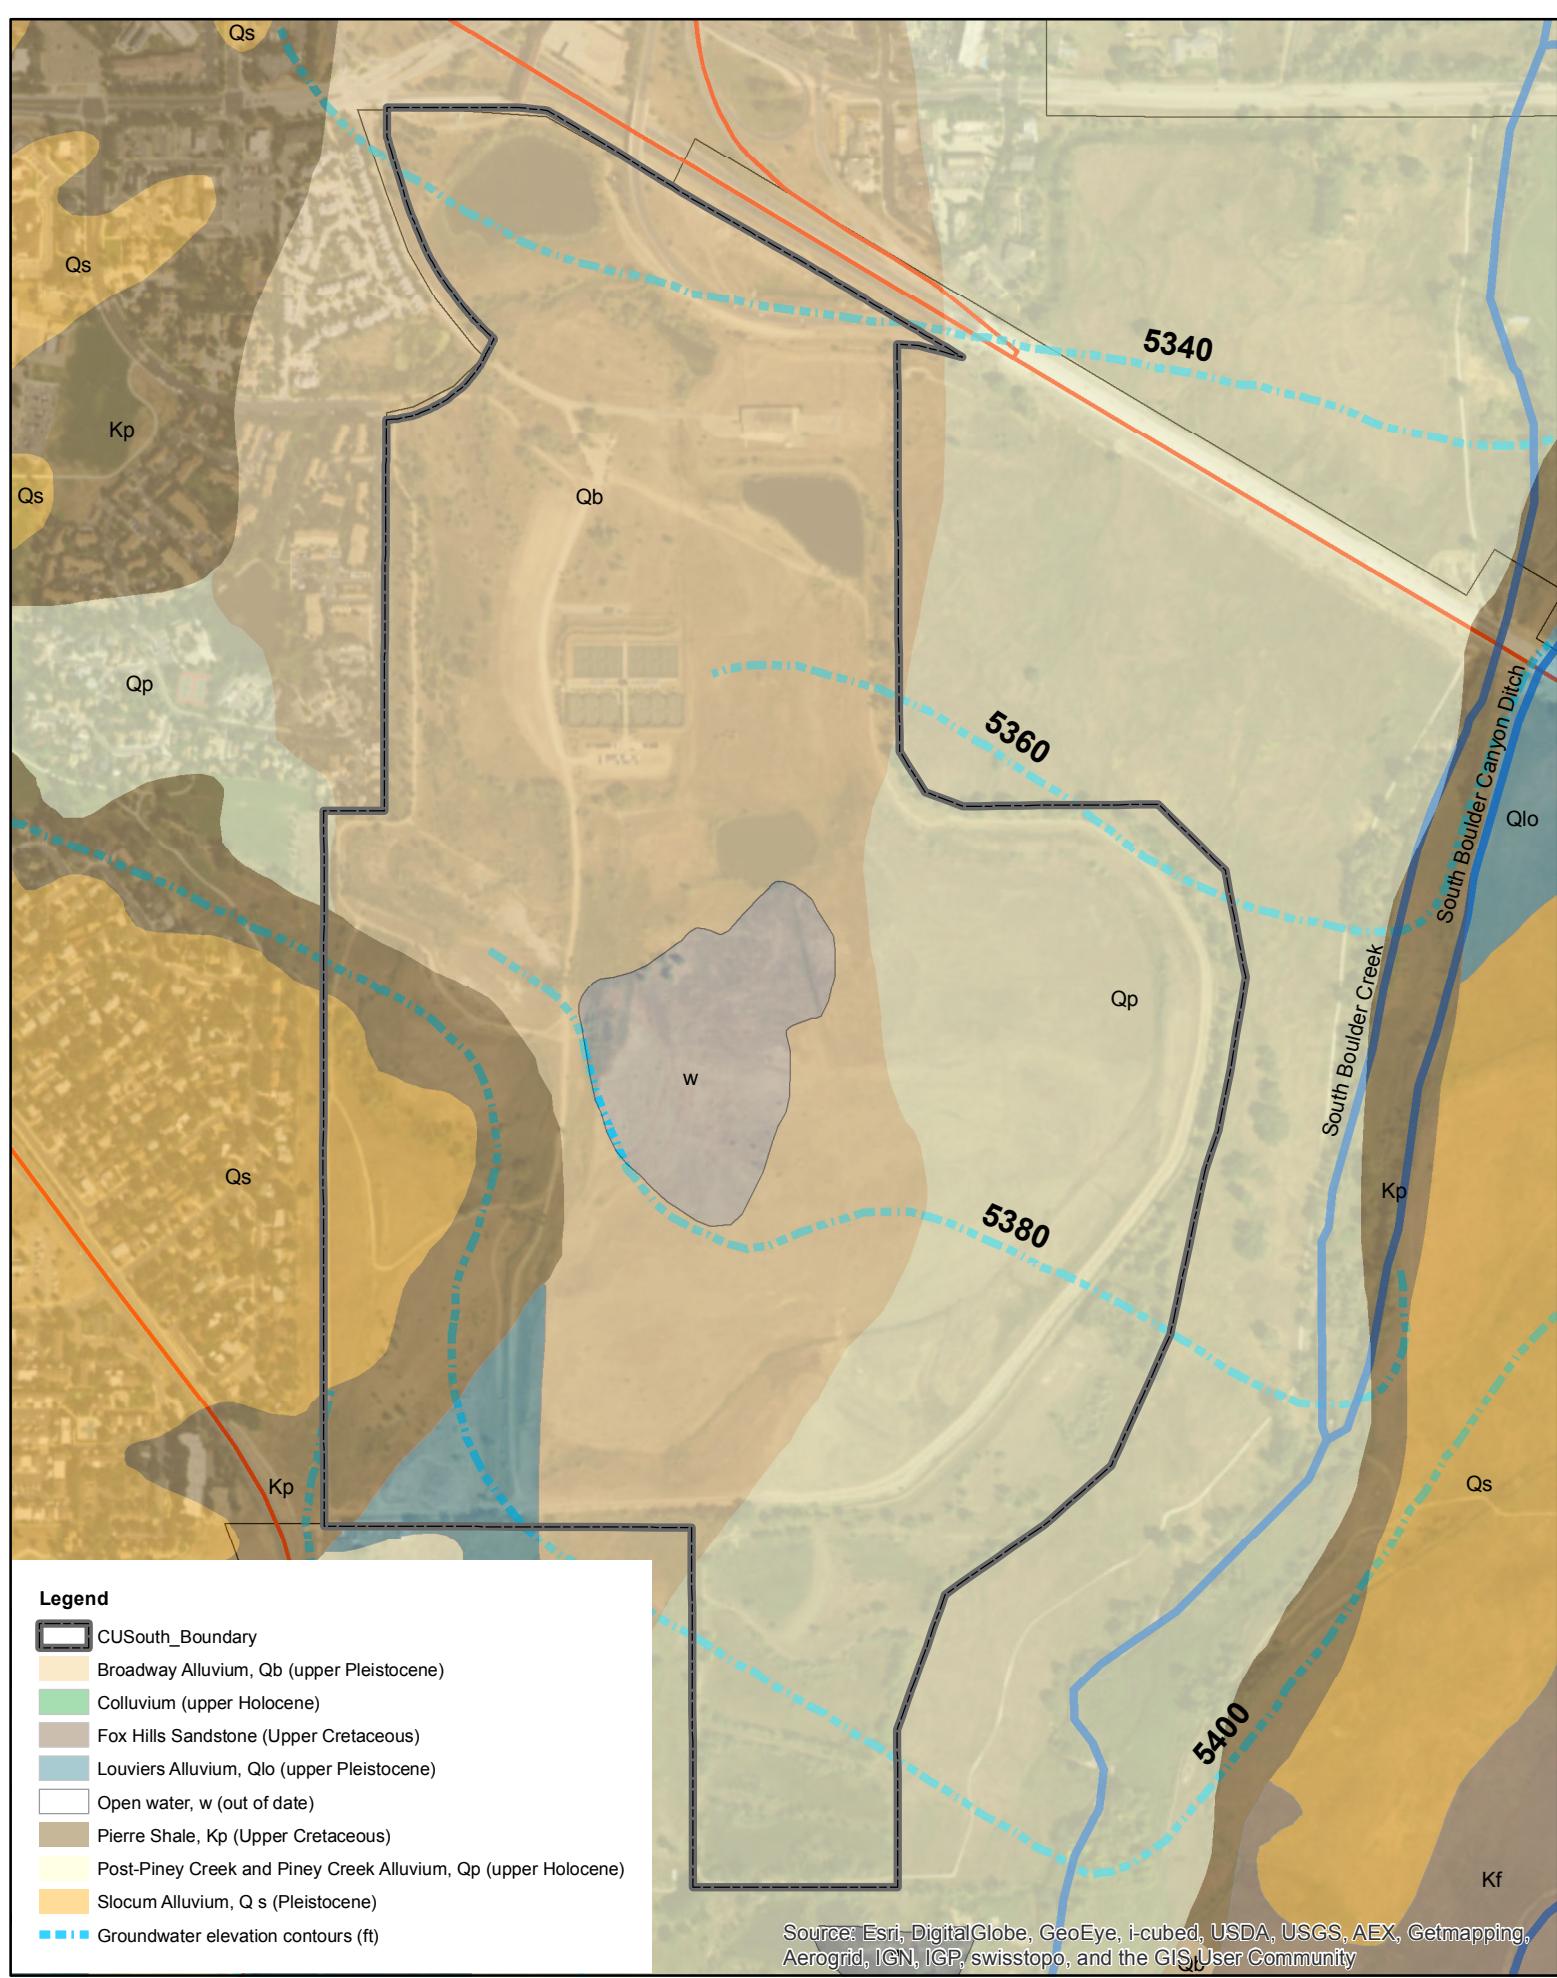
Figure 5
Geology and Regional Groundwater
CU South

Shallow groundwater occurs beneath most of the property in an unconfined sand and gravel aquifer (sometimes called a water table aquifer). Because groundwater may support baseflow and vegetation in the riparian areas along the creeks, understanding and maintaining groundwater hydrology can be important for long-term viability in these ecosystems. In

unconfined systems, precipitation infiltrates in upland areas to recharge groundwater, and the groundwater moves through the subsurface generally following topography until it reaches discharge points. Groundwater discharge occurs where the aquifer intersects the ground surface, and water is released into lakes, seeps, or springs that feed streams and wetlands. Water table aquifers will fluctuate up and down with seasonal and annual climate variations. In the Front Range, the water table generally rises in the winter, peaks after spring snowmelt, and decreases steadily throughout the growing season. Droughts and human water management practices associated with new development (e.g., diversion ditches, wells, sump pumps, and storm sewers) can cause significant long-term changes in the water table.

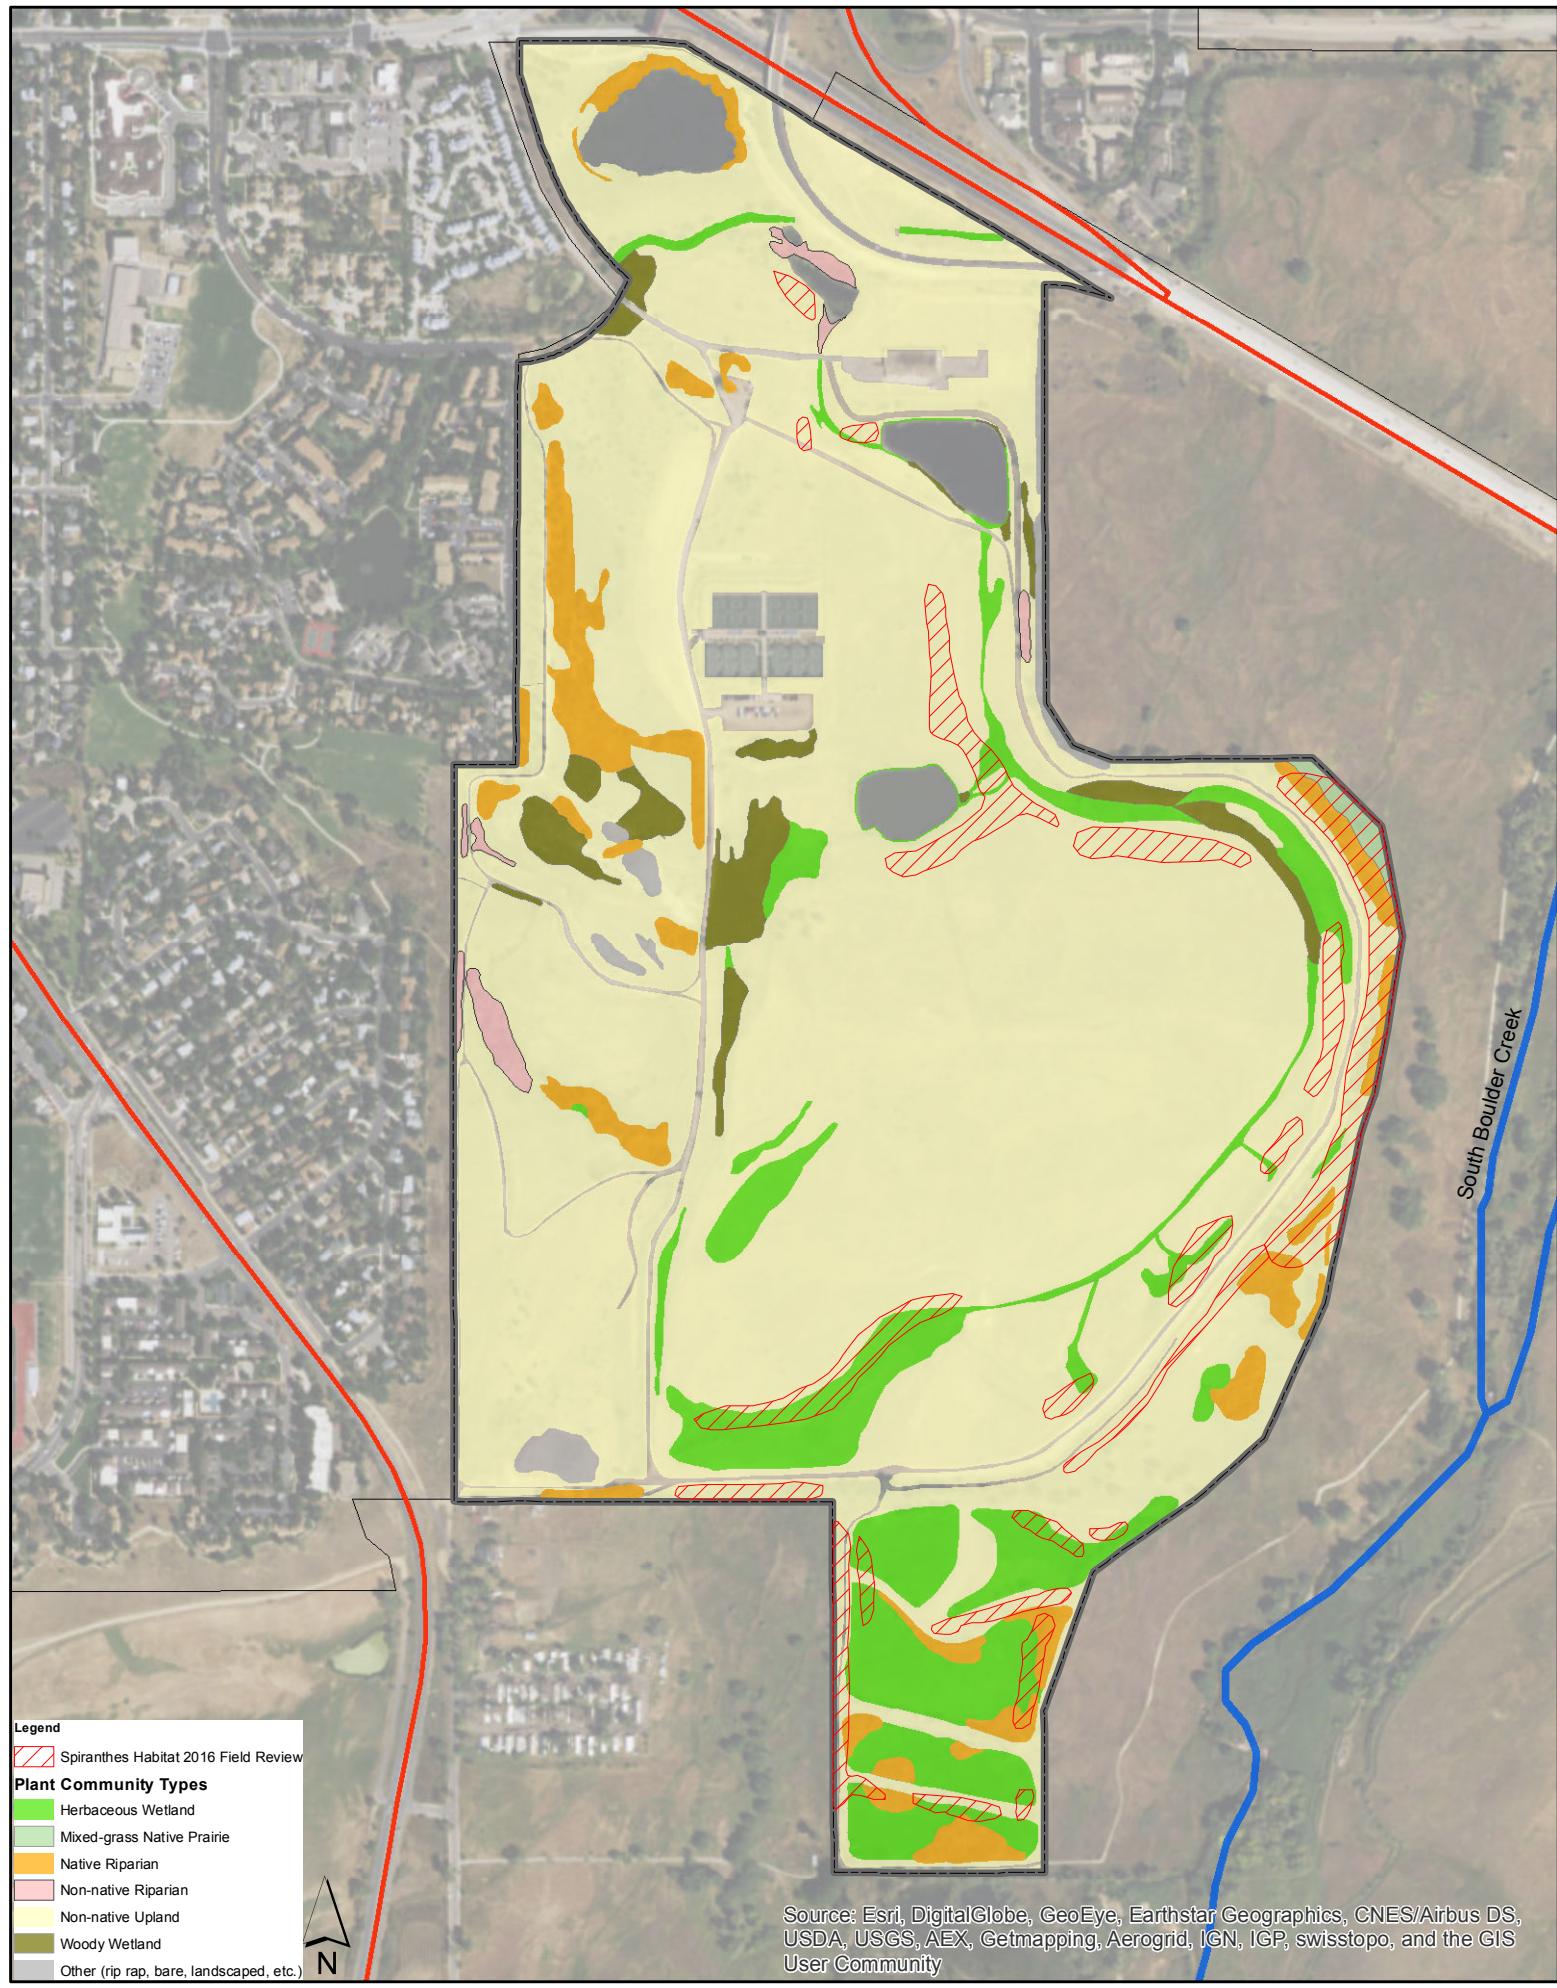
Figure 7
Plant Communities of the Property
CU South

Plant community mapping was completed on June 21 and 27, 2016, to evaluate the vegetative component of conservation suitability at CU South (Figure 7). Key objectives of the mapping were to identify boundaries of major community types (at a ¼-acre scale) and to note the condition of each community based on whether dominant species were native or non-native. The OSMP Grassland Ecosystem Management Plan (2010) was used as a reference for defining the CU South plant communities. As shown in Table 2, four native communities were identified: Mixed Grass Prairie Mosaic, Native Riparian, Herbaceous Wetland, and Woody Wetland.³ In addition, there were non-native communities labeled Non-Native Riparian, Non-Native Upland, and an “Other” category for development, large patches of bare ground, salt flats, and living fences.

Note: 2016 wetland plant community mapping
is based on rapid assessment and did not include
delineations for regulatory purposes.

Figure 7 shows the areas identified as potential Ute ladies' tress orchid habitat at CU South based on OSMP's rapid assessment. Four individual *Spiranthes* plants were observed in association with a patch of herbaceous wetland adjacent to the berm close to the southeast edge. As shown on Figure 7, most of the potential habitat is identified in the eastern portion of the property, with additional patches located around the cattail wetlands in the southernmost "panhandle" as well as smaller areas adjacent to the ponds in the northern portion.

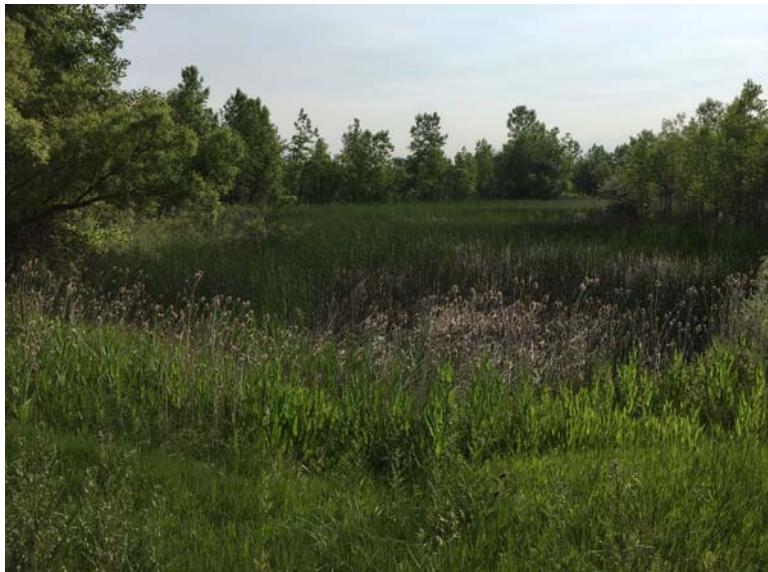
Photograph 1. Mosaic of native riparian/herbaceous wetland communities in southernmost portion of CU South property. Native riparian patches are dominated by plains cottonwood.

Native riparian communities, comprising 16 acres (5%) of the survey area, are wooded areas with sufficient soil moisture to support trees and shrubs, and at CU South they are most commonly located near a water source such as a ditch or a wetland. Native riparian communities were observed forming a mosaic with the herbaceous wetlands in the southernmost leg of the property (Photograph 1), in the South Boulder Creek floodplain along the eastern boundary, and along the western terrace. Plains cottonwood (*Populus deltoides*) is the dominant species in all native riparian communities of the study area. The most commonly observed associate was non-native Russian-olive (*Elaeagnus angustifolia*). Ash (*Fraxinus pennsylvanica*) and peach-leaved willow (*Salix amygdaloides*) are also typical.

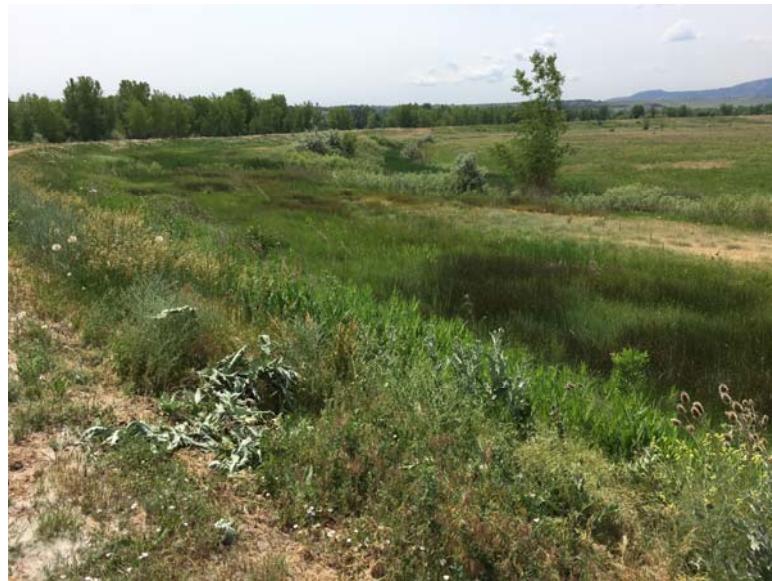
Photograph 2. Herbaceous wetland on the inside of the berm; photograph faces east-southeast. Dominant species in this patch are rushes, sedges, and cattail.

Herbaceous wetlands cover 30 acres, or approximately 10%, of the survey area. The largest patches are located in the southernmost portion of the property, but they are also characteristic of the inner slope of the berm (Photograph 2) and occur sparsely around the ponds.

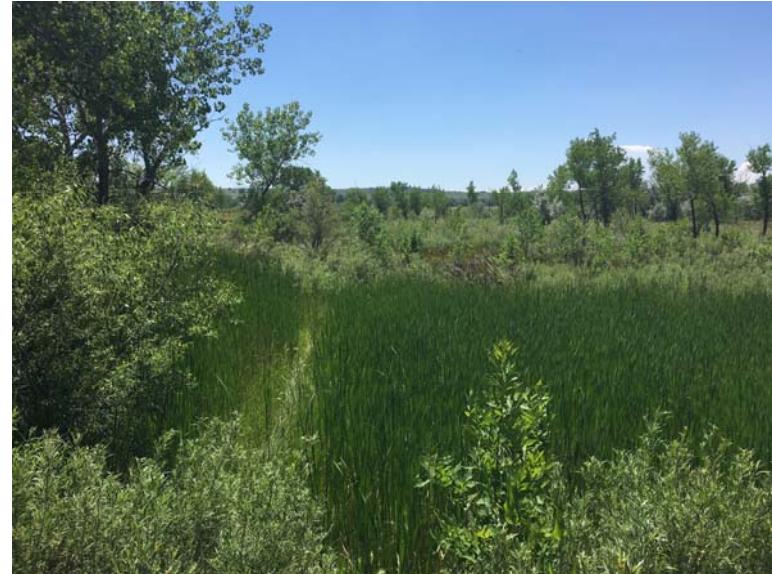
Photograph 3. Woody wetland complexed with cattails on the west side of CU South. Photograph faces south.

Similar to other woody wetlands of the Boulder County area, the woody wetlands in the survey area are dominated by sandbar willow. Associates commonly include cattail, sedges, and rushes (Photograph 3). Peach-leaved willow was also observed.

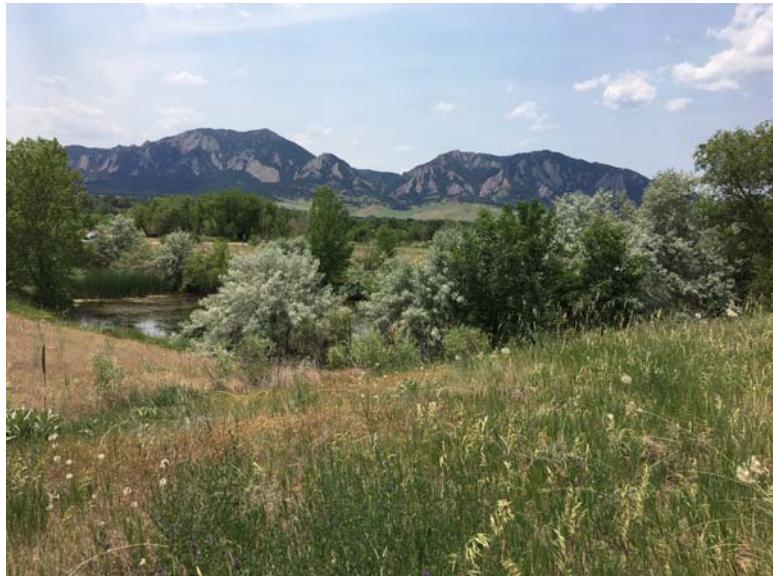
Photograph 5. Non-native riparian community around the shoreline of a pond in the northern portion of CU South. Non-native upland is in the foreground.

Non-native riparian communities were relatively small at CU South covering only 2 acres (1% of survey area). These isolated patches occurred around one of the ponds in the northern portion of the site (Photograph 5), and along the eastern and western boundaries. Russian-olive was the typical dominant, but Siberian elm (*Ulmus pumila*) and crack willow (*Salix fragilis*) were dominant in some of these patches. Sandbar willow is a frequent associate and ash was also observed.

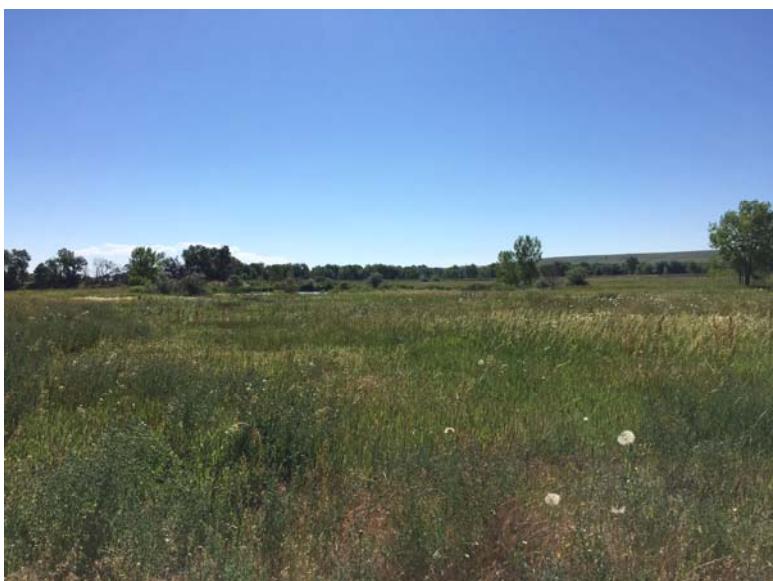
Photograph 4. Non-native grassland at CU South. Dominant species are cheatgrass and alfalfa. White tufts are yellow salsify.

Non-native grassland comprises 233 acres (80%) of the property. The magnitude and features of this community reflect its history of disturbance including mining. Dominant species are cheatgrass (*Anisantha tectorum*) and alfalfa (*Medicago sativa*), and associates include bindweed (*Convolvulus arvensis*), yellow salsify (*Tragopogon dubius*), and smooth brome (*Bromopsis inermis*; Photograph 4). Patches of western wheatgrass were also observed.

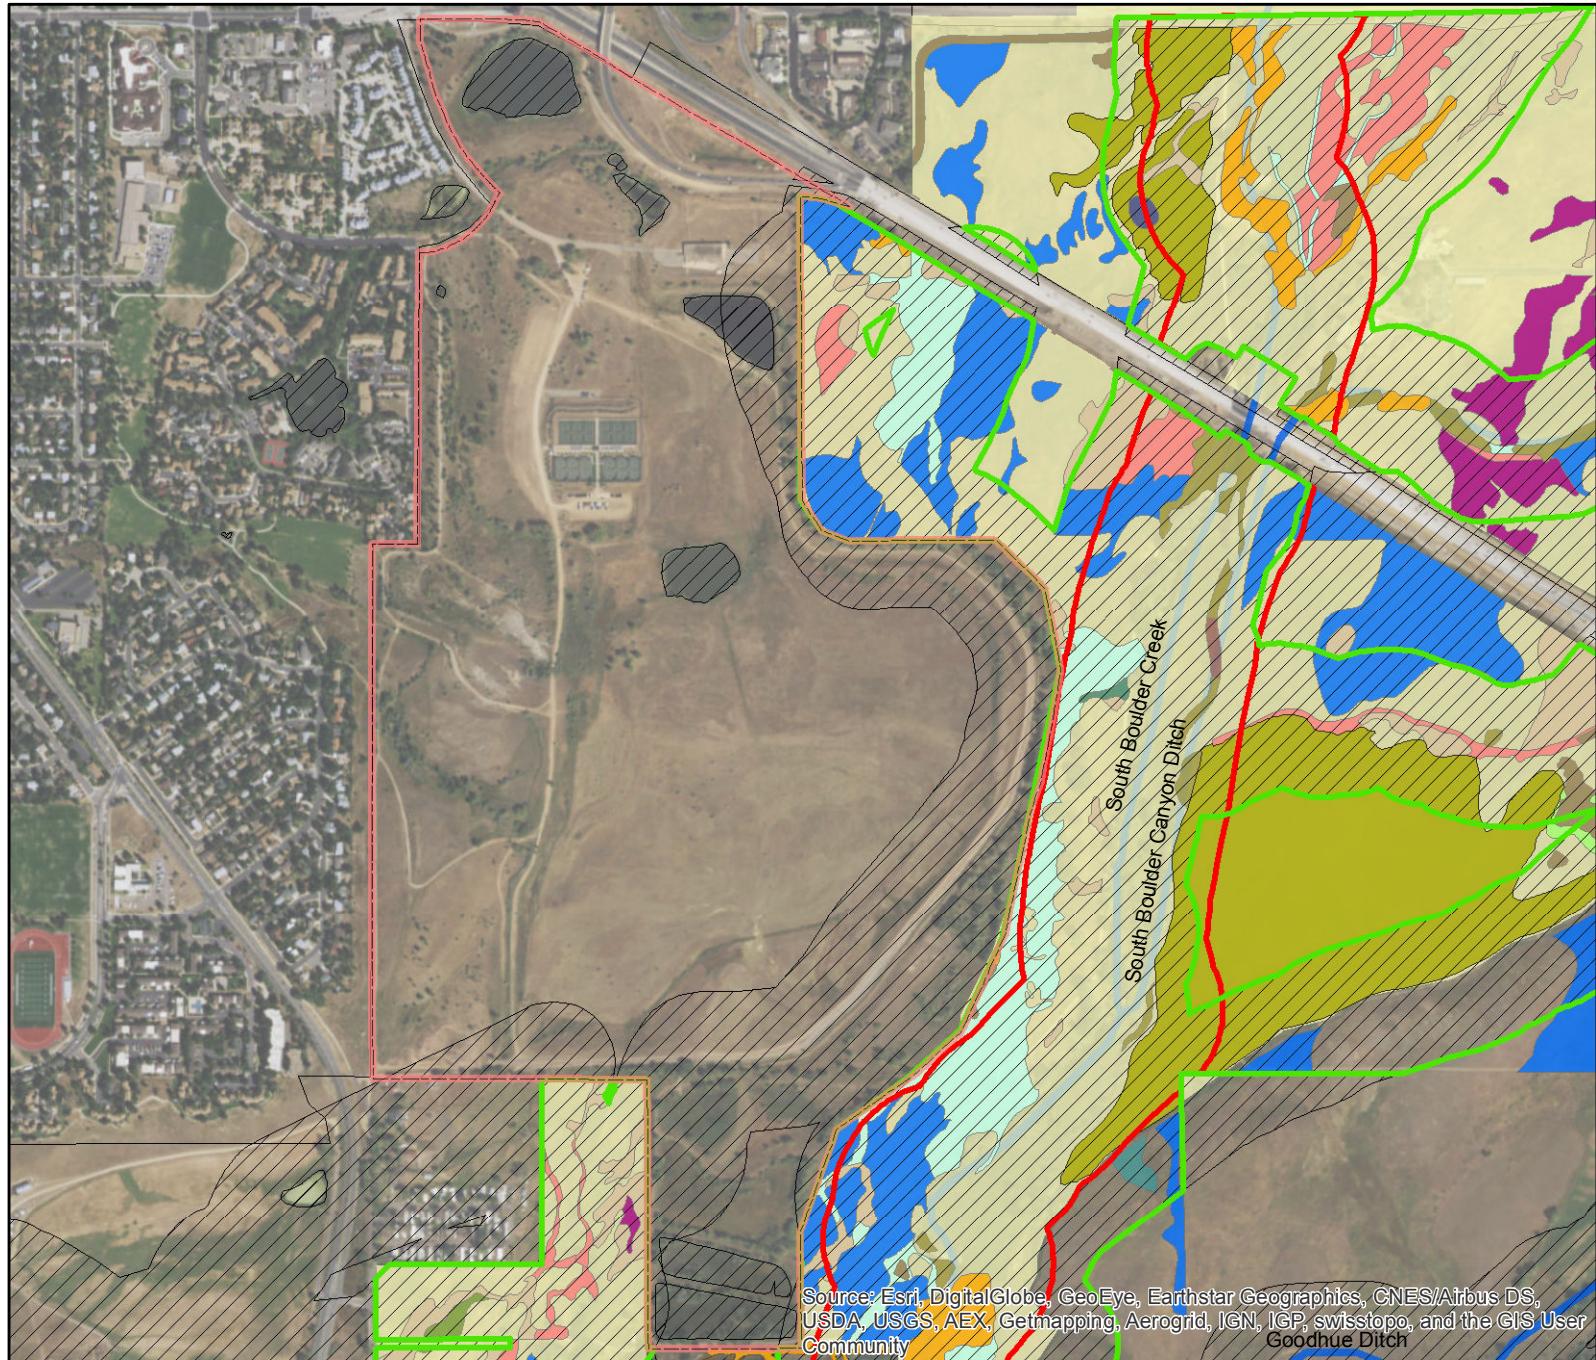
Figure 8b shows the designated conservation areas for the Preble's meadow jumping mouse along with the plant communities that are tracked by CNHP and OSMP. Preble's was positively located within ca. 300 meters of the property as recently as 2014. Preble's meadow jumping mouse (Preble's) habitat is a riparian ecosystem characterized by a high cover of shrubs, grasses, and forbs, and adjacent uplands that are used for foraging and hibernation. Typical habitat is found in the foothills of the Front Range ranging from southeastern Wyoming to Colorado Springs. Preble's is primarily nocturnal and a true hibernator, entering hibernation in early fall (Sept-Oct) and emerging in May. Its diet, comprised of insects, seeds, fungus, moss, pollen, and fruit, changes seasonally according to the availabilities of different foods.

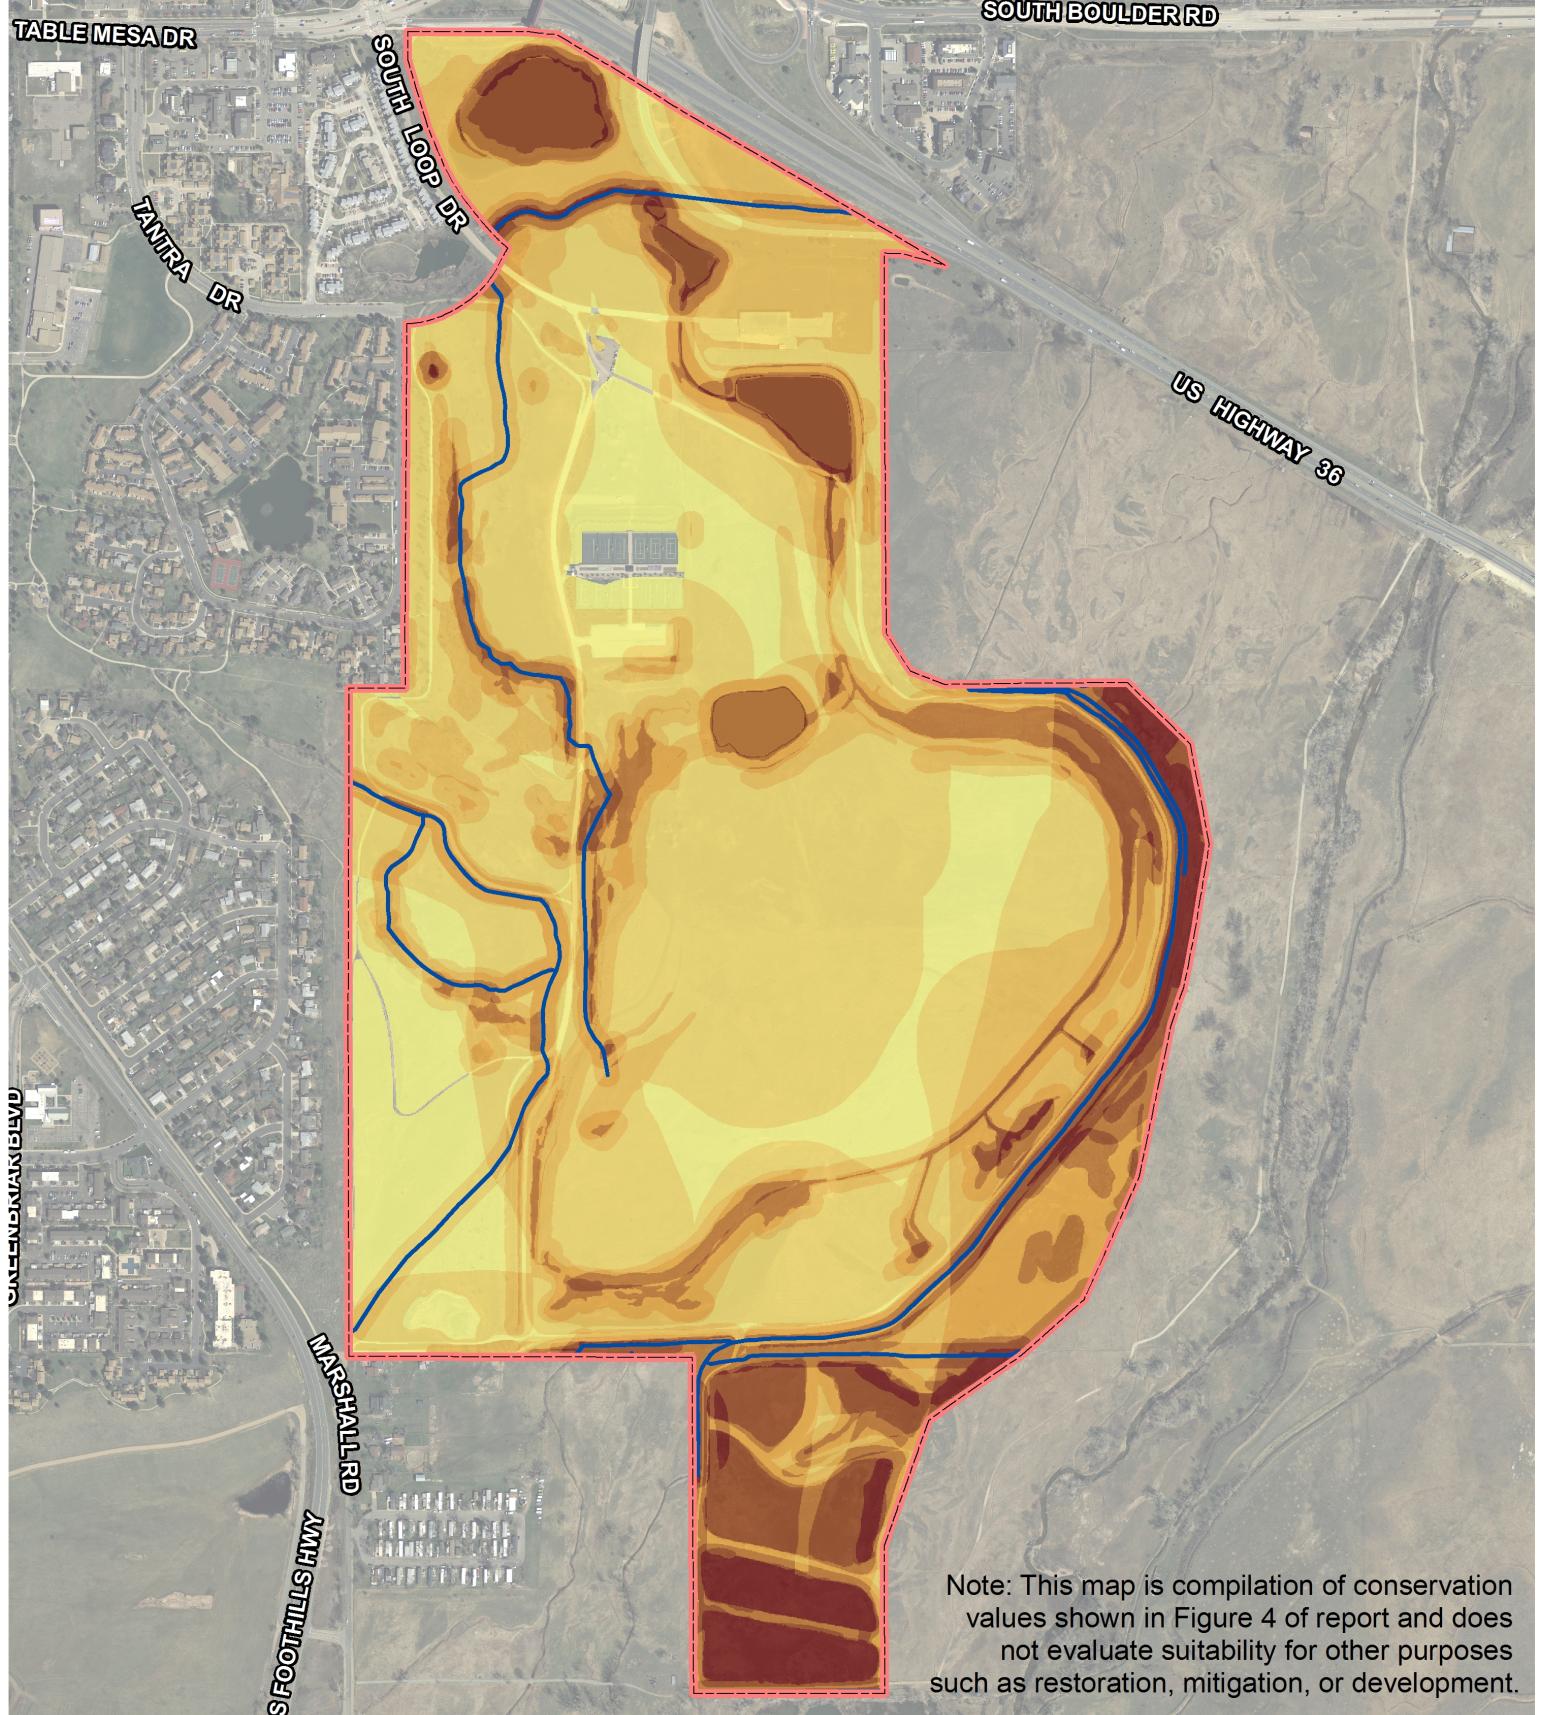
Figure 9
Site Conservation
Suitability Analysis
CU South

High : 10
 Note: High=greater conservation value, and
 Low=less conservation value

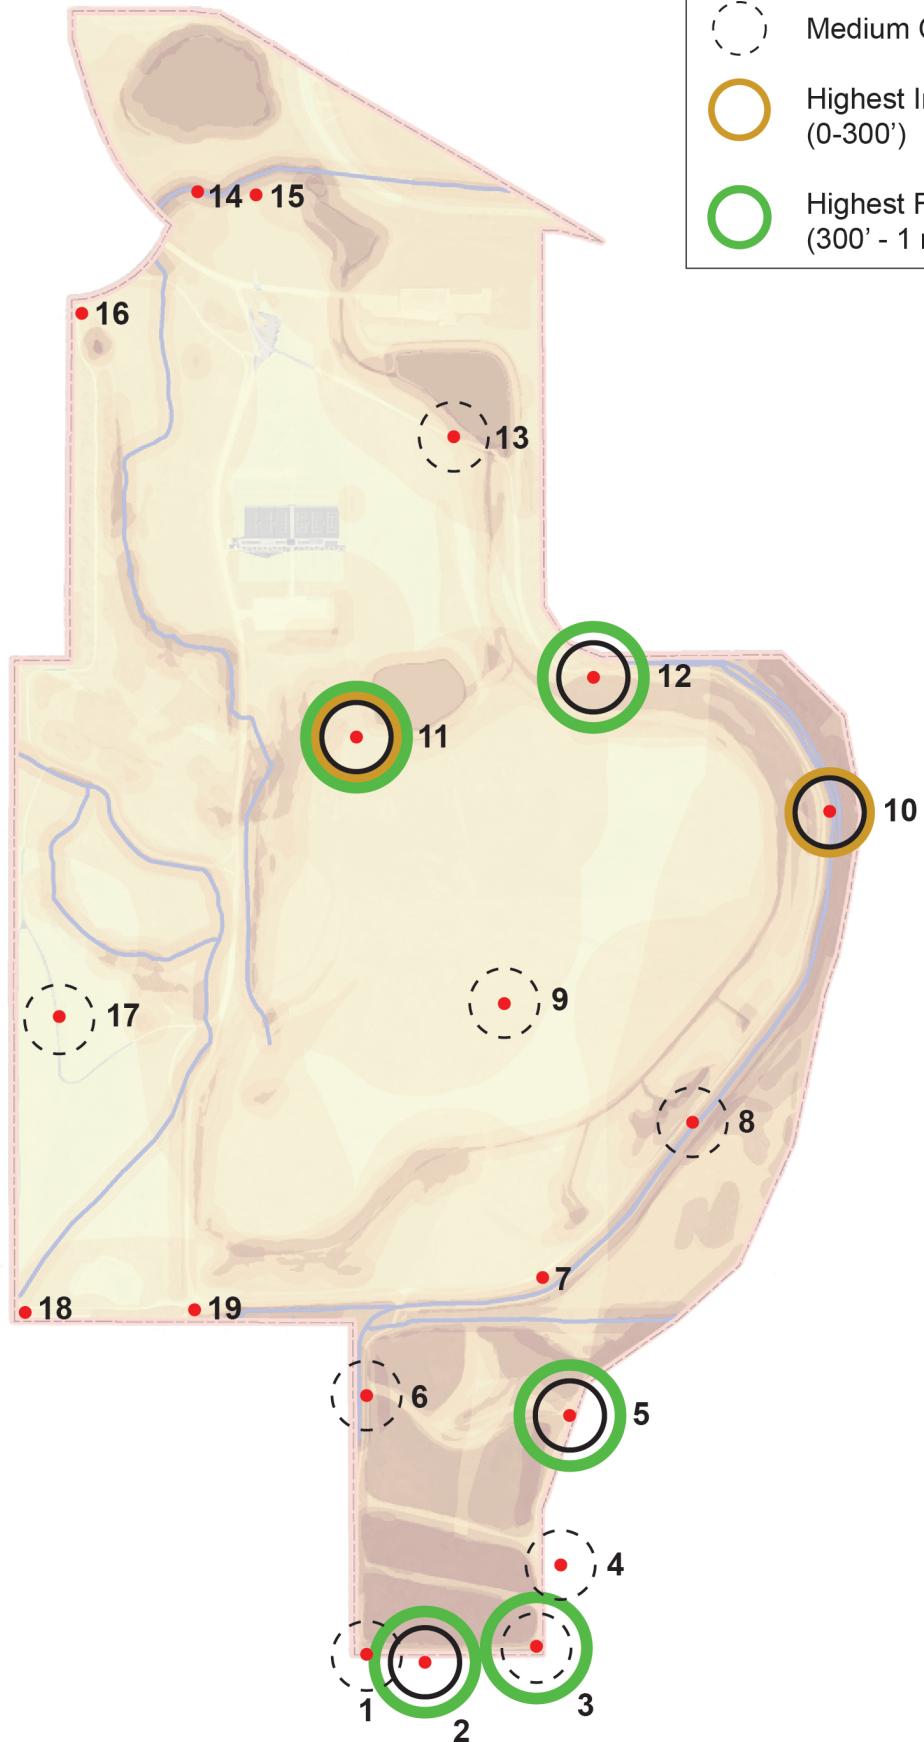
Figure 11 presents a conceptual sketch of photopoint values, depicting the areas of the site with view features based on the assessment detailed in Section 2.3 above (further detail in Table A-1, attached). The outline of the point and the color reflect an initial value of key landscape characteristics at these points. This is a preliminary exercise which may need refinement once stakeholder input is gathered.

- Highest Overall Score
- Medium Overall Score
- Highest Immediate Viewshed (0-300')
- Highest Foreground Viewshed (300' - 1 mile)
